PRESENT-DAY GEOMORPHOLOGICAL PROCESSES IN THE VEDIȚA CATCHMENT

Alina BEJINARIU, Anișoara STAN¹

Abstract: The river Vedița is situated in the middle section of the Cotmeana Piemont. It is delimited Westwards by the hydrographical basin of the Vedeia river and Eastwards by the hydrographical basin of the Cotmeana river. From a geological point of view, it is located in the Getic Ground, which was a sedimentation area. This area is made up of Căndești Stata which are made of sand in alternation with gravel with lens of clay. This geological structure is the main factor for the present dynamics of the relief. In the hydrographical basin of the Vedița river, the main processes regarding the relief dynamics are: torrents, scrub in area, landslips and landslides. There are some elements which influence this processes, such as: the relief characteristics, the human land use and the climate parameters.

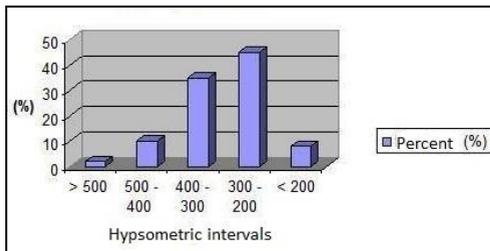
Fig. 1. Hypsometry

The relief influences the terrain dynamics through four of its characteristics: density of relief fragmentation, fragmentation depth, geodeclivity and hypsometry (Fig. 1, 2).

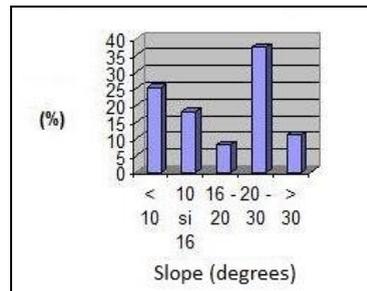
Fig. 2. Geodeclivity

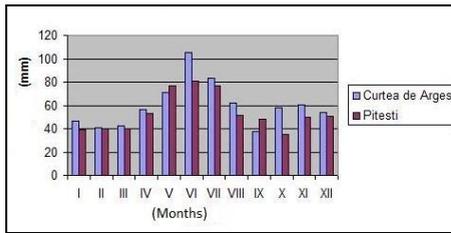
Fig. 3. Monthly rainfall

The climatic factor also influences the actual modelling through two parameters: temperature and rainfall. These parameters register maximum values in June, July, August, with direct implications in activating and developing torrential streams, but also a higher stress exerted by the river flow on the banks, increasing the risk of collapse (Fig. 3, 4).

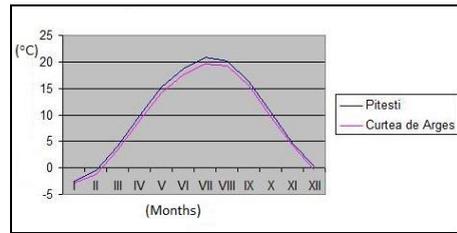
Fig. 4. Air temperature

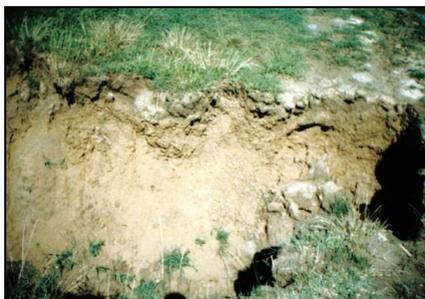
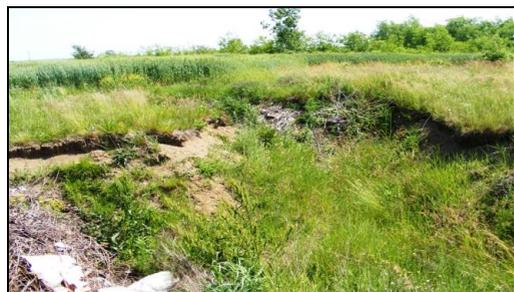
Photo no. 1. The drainage basin of the Ciocănești torrent (2005)

Photo no. 2. The drainage basin of the Ciocănești torrent (2008)

Among the slope processes, there are to be noted the rainwash and the sheet erosion; gully erosion and torrentiality; as erosion processes induced by the water flow concentration on slopes and in the riverbed, the gully erosion and the torrentiality characterize the entire Vedița Catchment, but especially the right slope. The torrential flash floods are extremely strong because of the large development of the drainage basins on the quasi-structural surface that forms the left slope of the Vedița. The erosion is characteristic to the lower half of the flow channels, where it becomes manifest both through their deepening, as well as through the lateral degradation of the banks and of the slope base. The lateral erosion of the torrents maintains the entire slope in a permanent state of imbalance (Photo no. 1, 2).

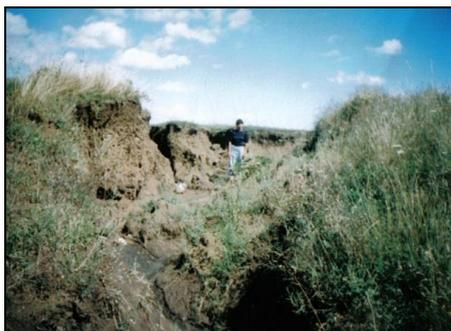
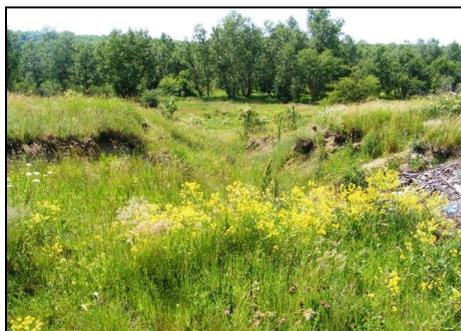
Photo no. 3. Ciocănești torrent (2005)

Photo no. 4. Ciocănești torrent (2008)

The year 2005 was characterised by high precipitation quantities, this aspect leading to the intensification of torrential erosion at the level of the River Catchment. The torrents began to enlarge their surface especially through regressive erosion in the drainage basins (Photo no. 3, 4).

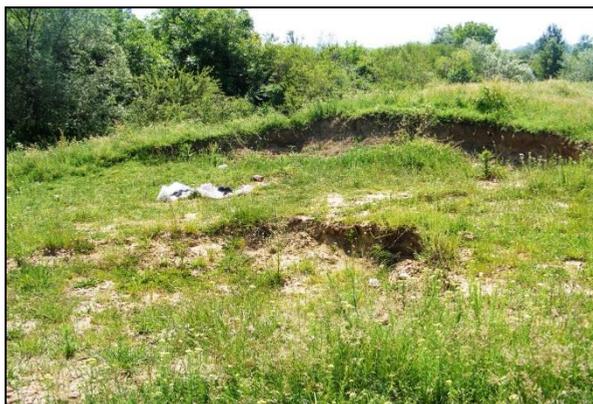
Photo no. 5. Landslide on the Vedița-the Boul interfluve

The extended surfaces that undergone deforestation in the Vedița catchment-especially those located on the slopes of its tributaries, the Ulmul Mare and the Boul (Photo no. 5), as well as in the lower sector of the Vedița - favoured the development of small-scale landslides (their development is not ample because the slope and the lithological conditions do not favour such an extension). Important rill and gully erosion processes accompanied the landslides, especially within the sectors where torrential erosion could install.

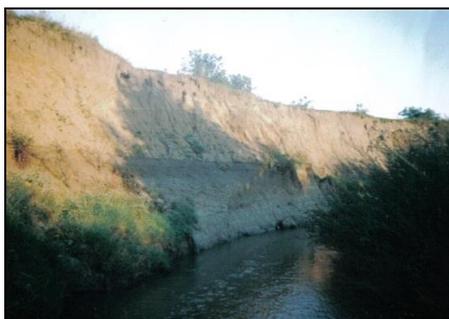
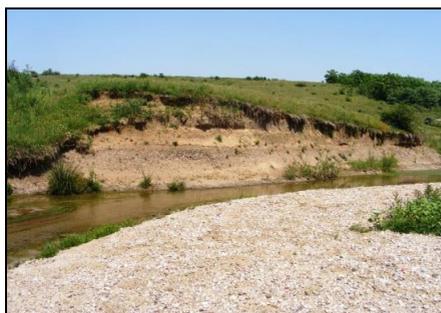
Photo no. 6. Left slope of the Vedița, between Guești and Vitănești settlements, 2005

Photo no. 7. Left slope of the Vedița between Guești and Vitănești settlements, 2008

The Vedița riverbanks are affected by lateral erosion, which leads, in the first stage, to the under-caving of the rock packages and the appearance of erosion marmites; subsequently, the rock packages located above would collapse under the action of gravitational force. This type of riverbank regression can be pointed out by comparatively analyzing the 2005 and the 2008 situations (Photo no. 6, 7). The geological constitution of the region, with the predominance of the Cândești Strata, favours the rapid regression of the slopes.

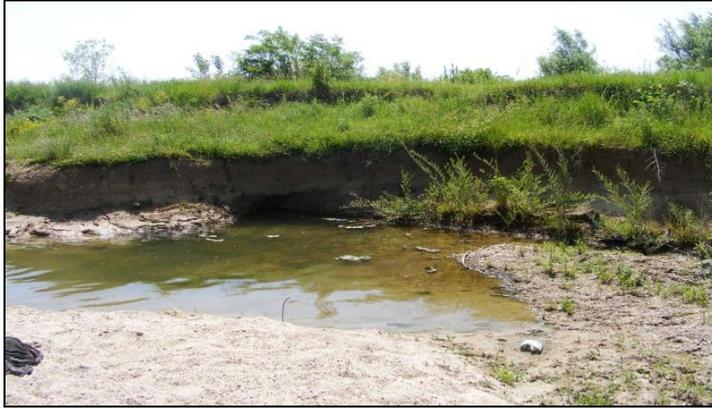
Photo no. 8. Slope collapse (subsidence) - Guești

The shore side erosion in these places is a permanent cause in triggering the shore collapses. Such situations occur on the left slope downstream of Guești (Photo no. 8) or on the left slope near Colonești locality.
