SOIL EROSION AND LANDSLIDES IN IZVORUL MUNTELUI LAKE AREA

Ioana Monica MUSCALU²

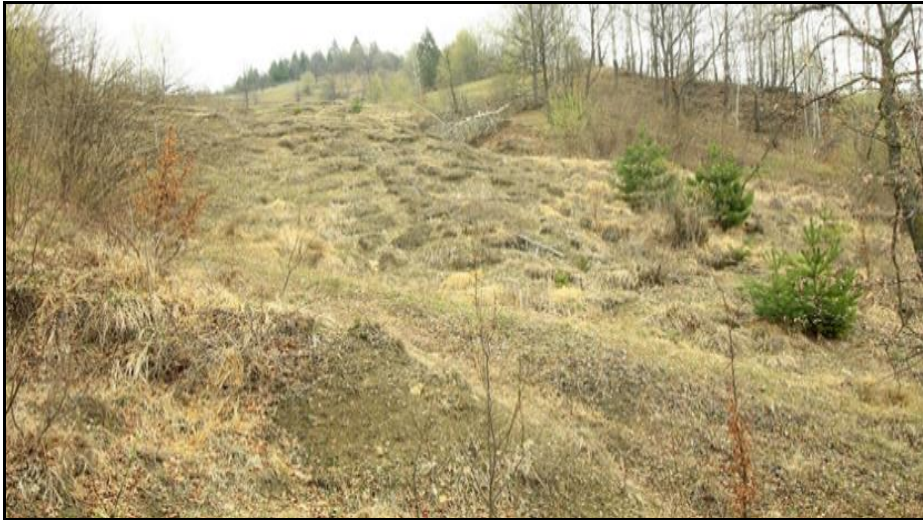
Fig. 2. Landslide near Borsec

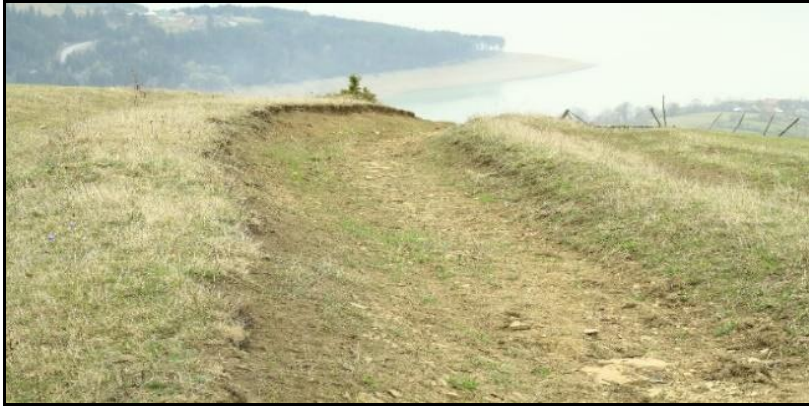
Fig 3. Road affected by erosion in Tulghes

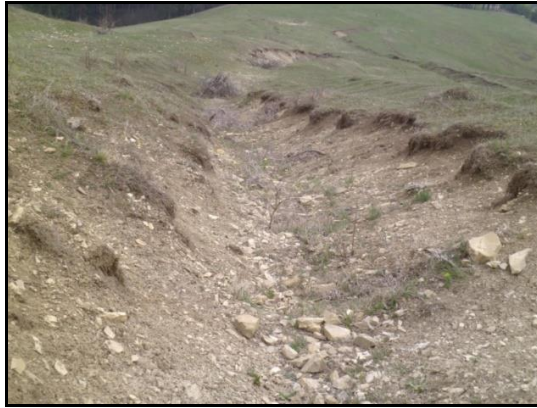
Fig 4. Erodisolts with very strong erosion, deep erosion, gully

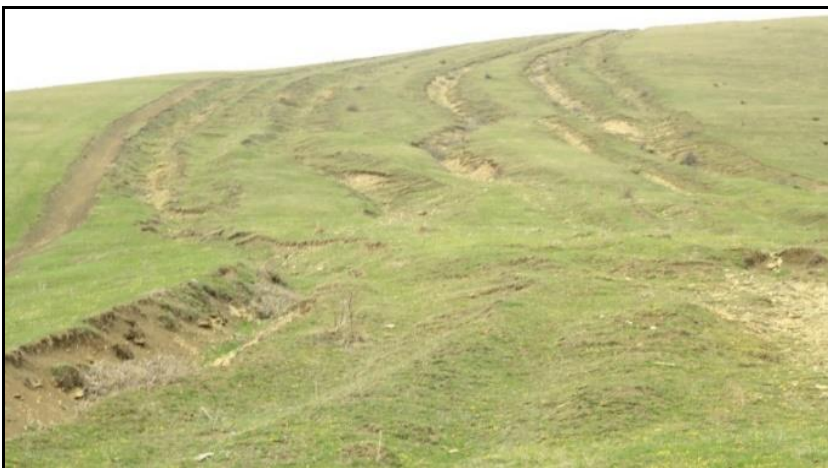
Fig. 5. Gullies, developed on a slope affected by landslides
